Sturgeon Lake/Dairy Creek Restoration Project

Pre-Project Conditions

Restoration Actions

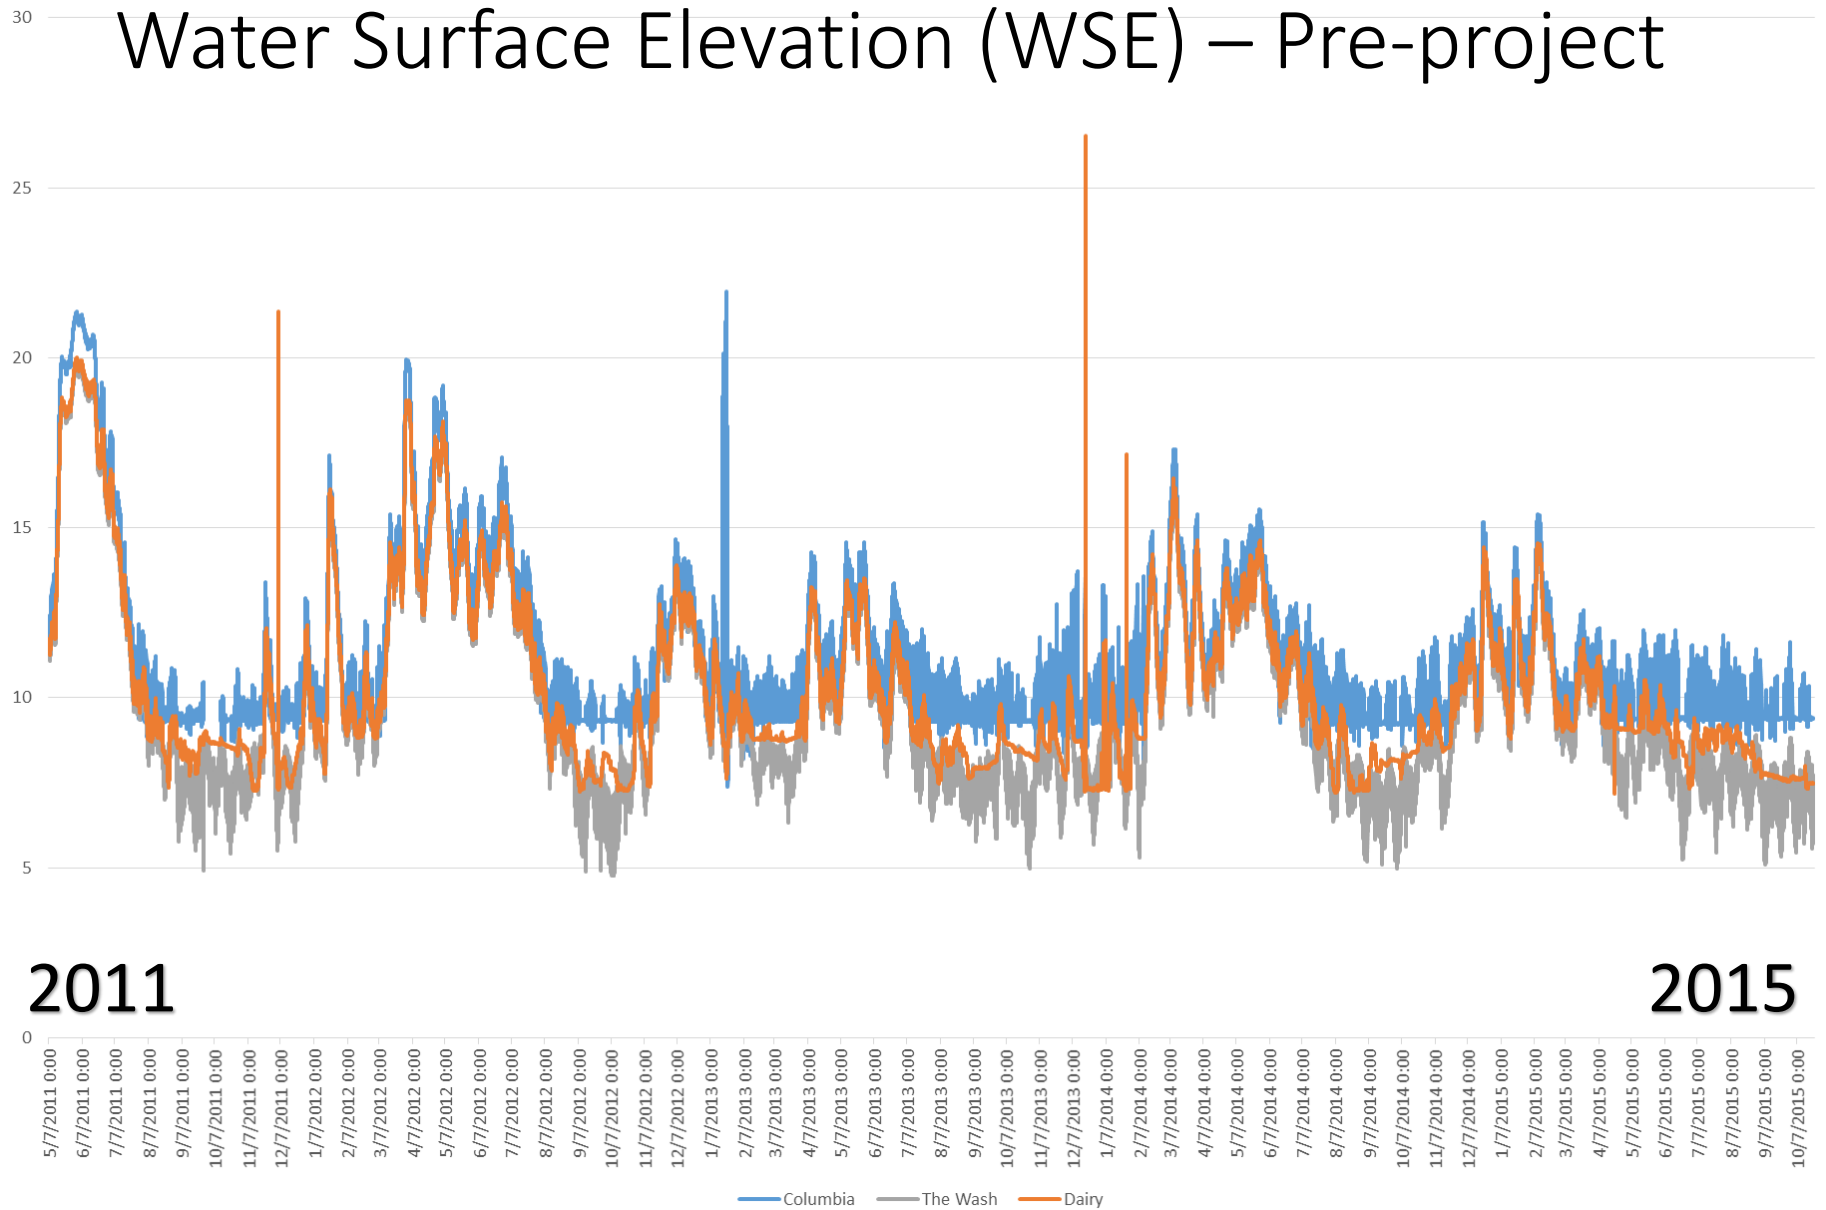
Water Surface Elevation (WSE) – Pre-project

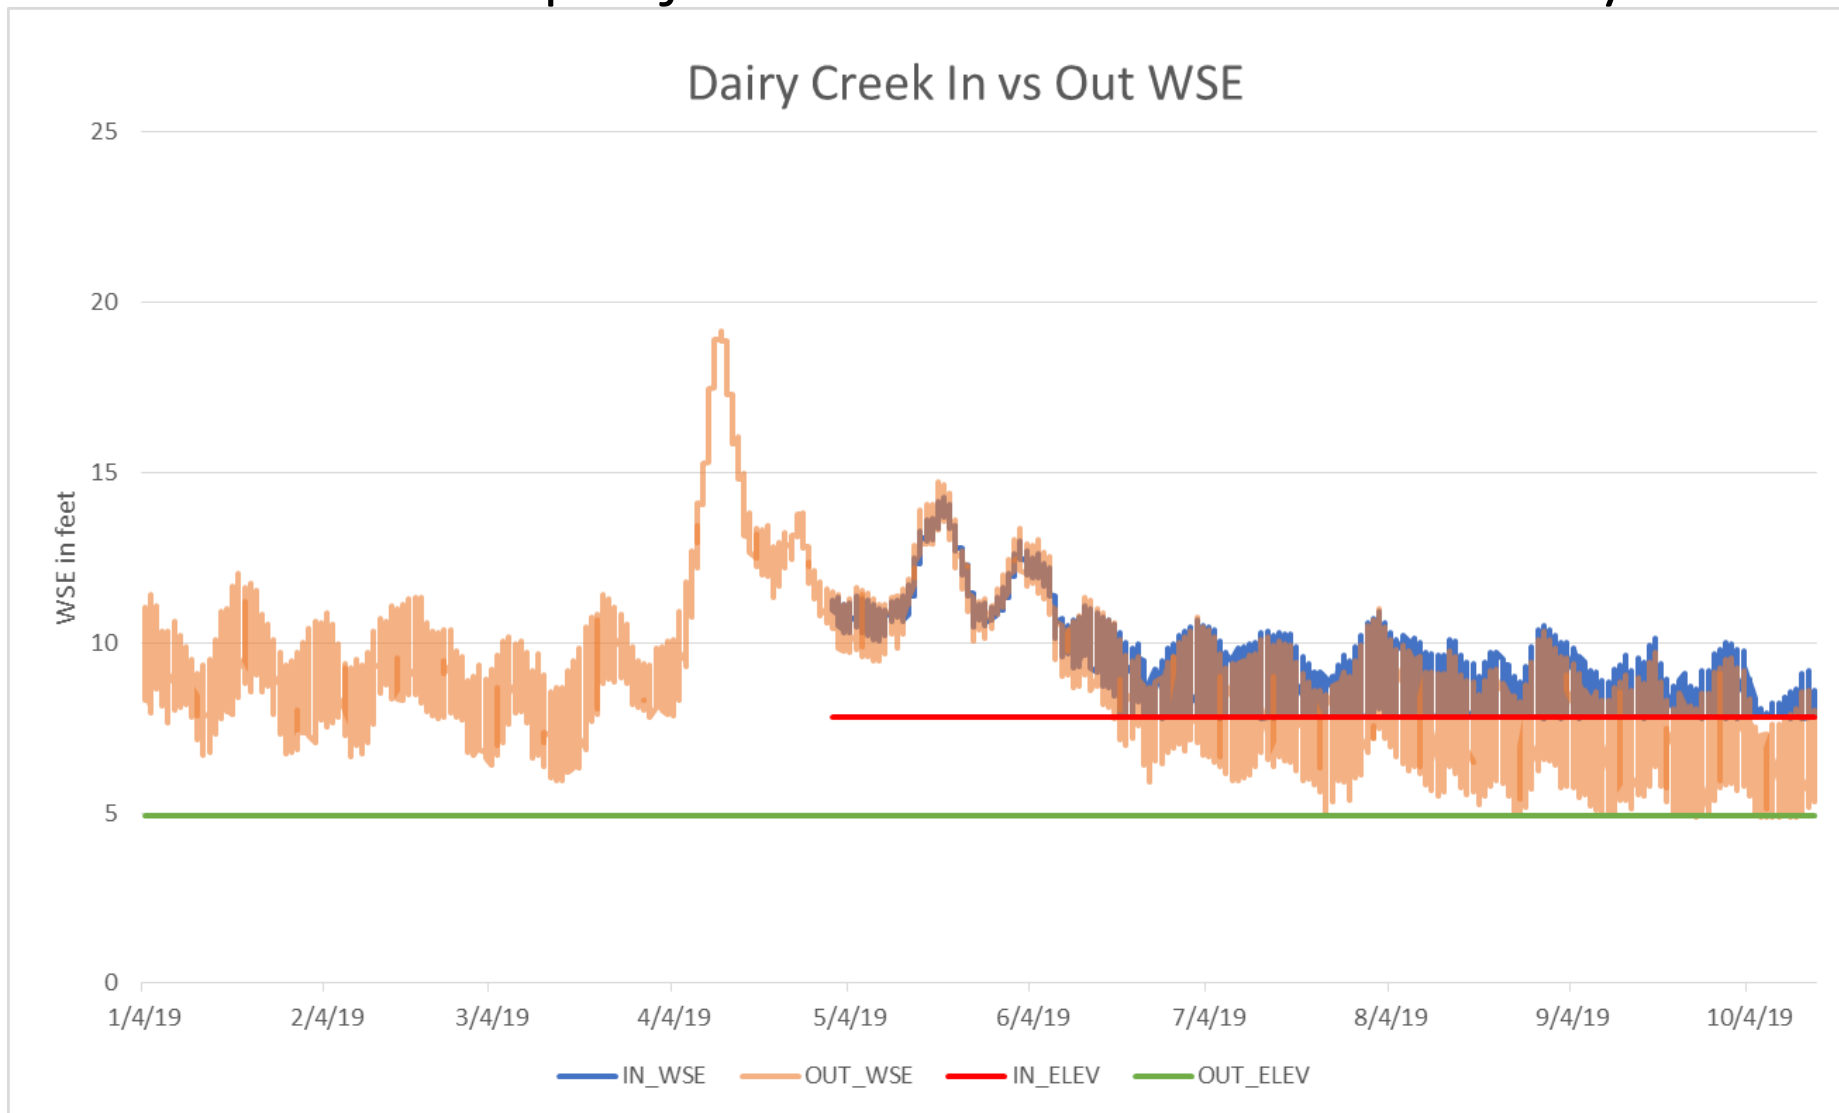
WSE – Post-project – 2019 – No lake data yet

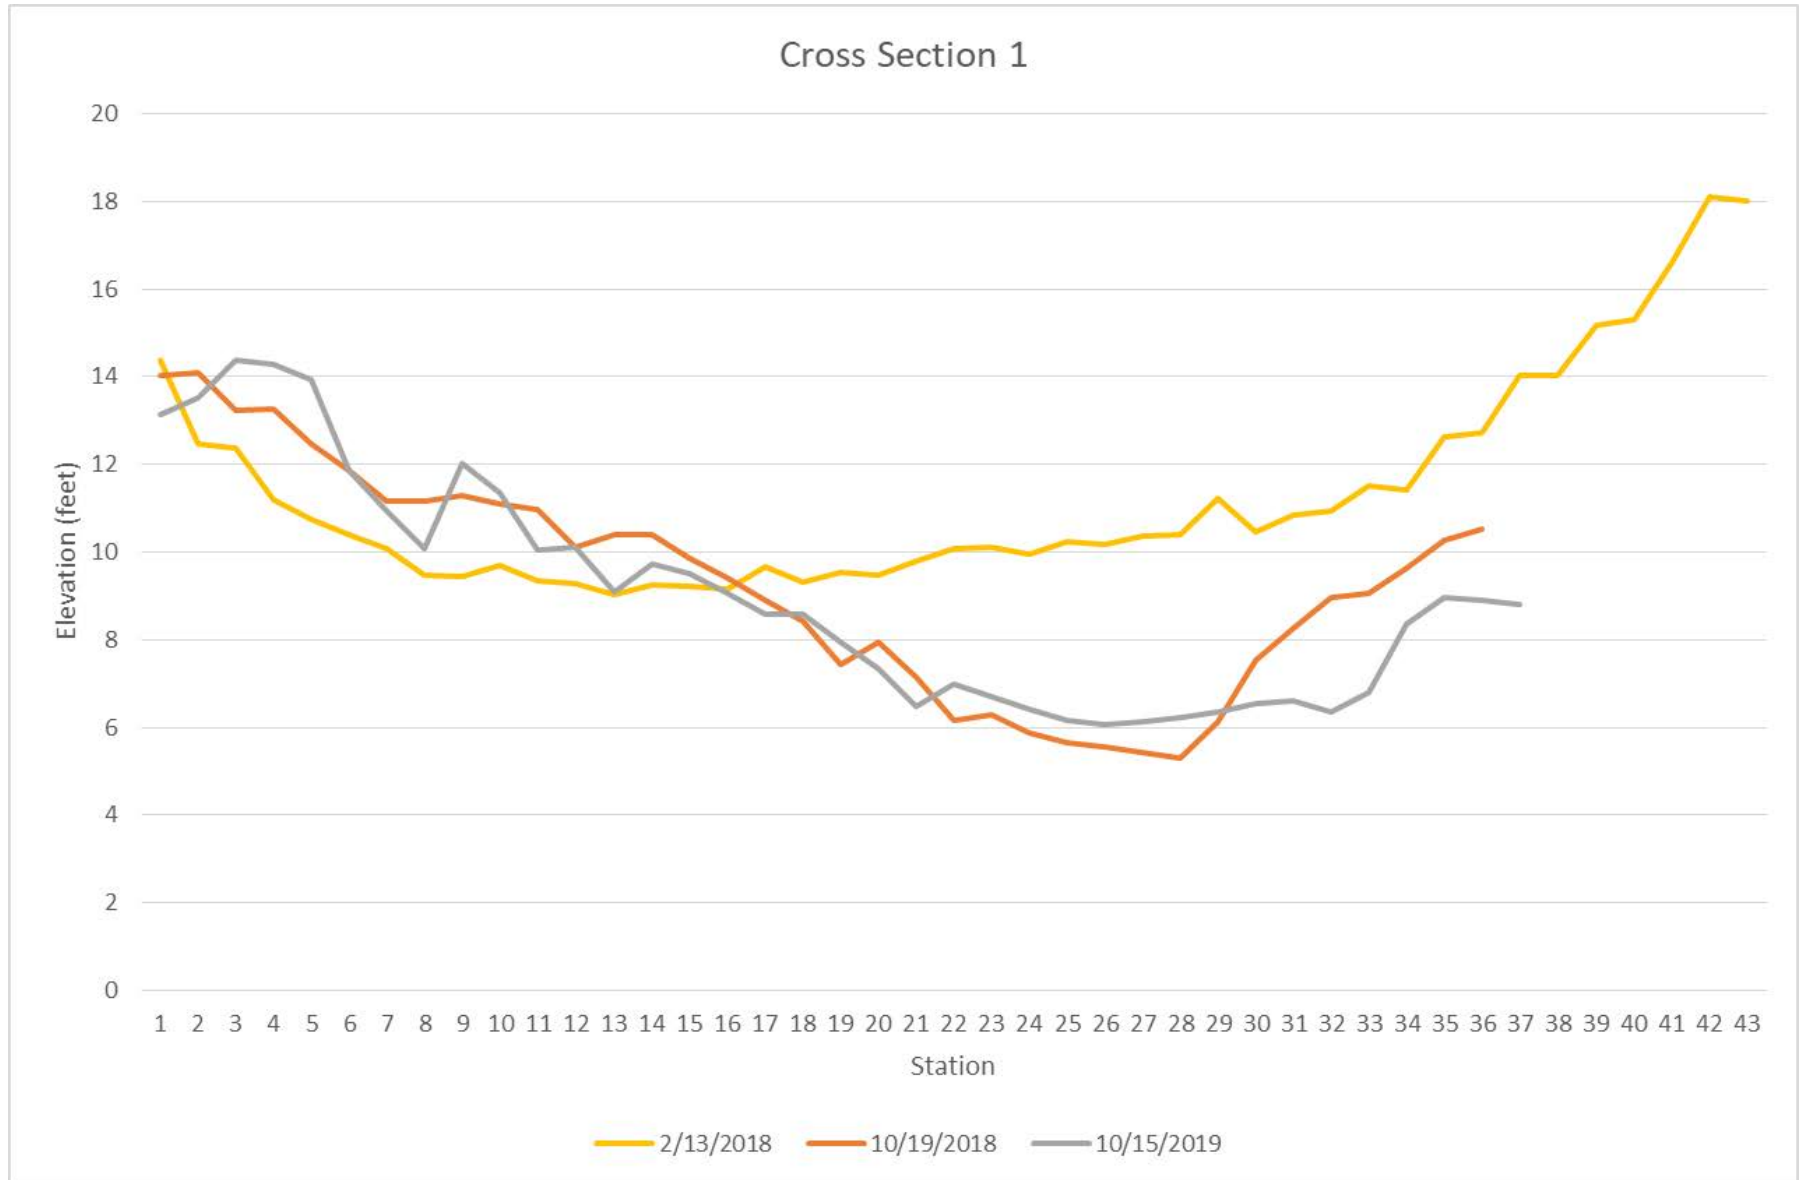
Channel Cross Sections – X1 - Mouth

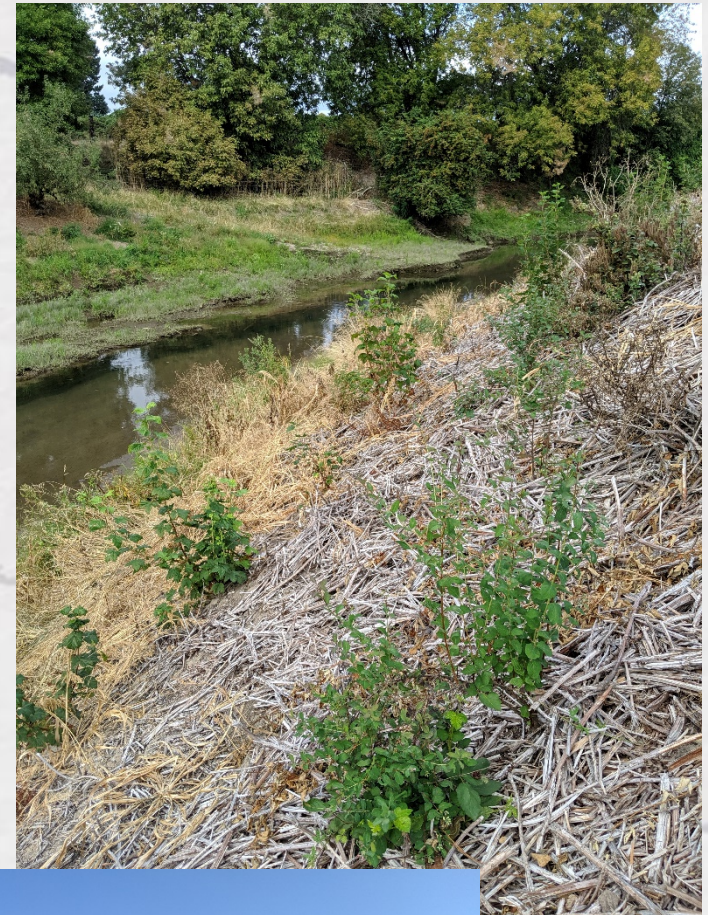
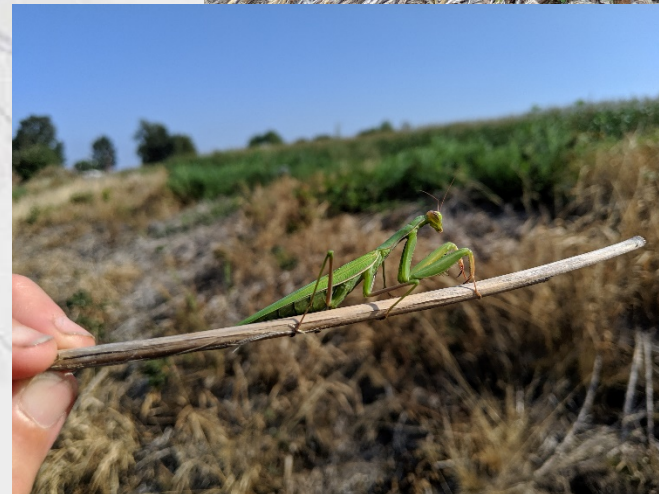
- WMSWCD Plantings 80-90% survival rates
 - Thanks in large part to ample site prep
 - 1.5 additional areas in 2020
- Plantings in Construction areas less than 50% survival
 - Compacted soils, low OW, no mulch, etc
 - Replanting this winter paid for by BPA
